Intel[®] IXP42X Product Line and IXC1100 Control Plane Processor: Using the Intel[®] LXT973 Ethernet Transceiver

Application Note

Document Number: 253429-002

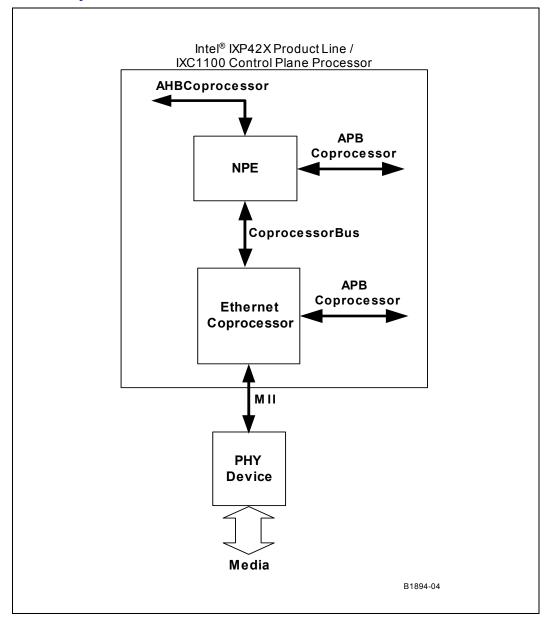
Figure 1. Ethernet System Overview

Figure 1 shows the architecture of the Ethernet implementation for Intel[®] IXP42X product line and IXC1100 control plane processors.
